Report No. UT-12.03

## HEALTH MONITORING OF PRECAST BRIDGE DECK PANELS REINFORCED WITH GLASS FIBER REINFORCED POLYMER (GFRP) BARS

Utah Department of Transportation  
Research Division

University of Utah  
Department of Civil & Environmental  
Engineering

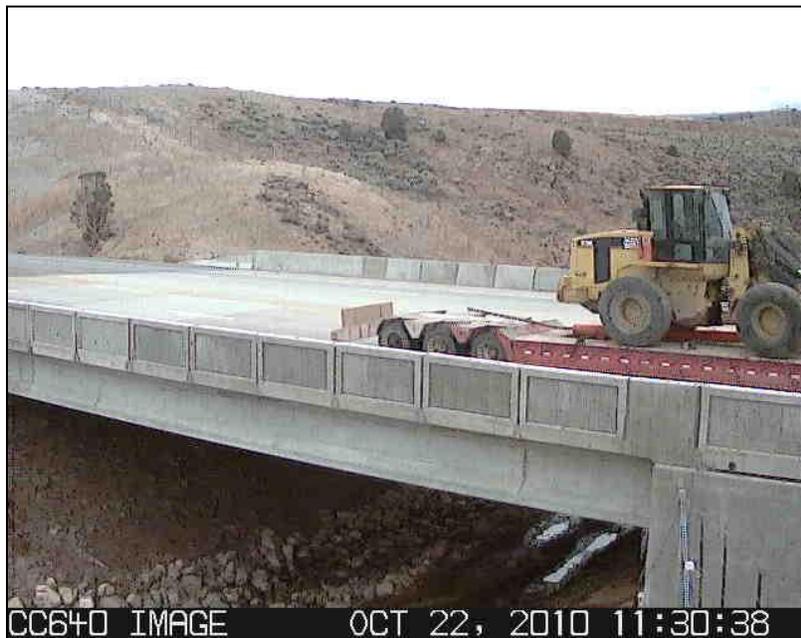
**Figure 46. Image for acceleration record of Oct. 22, 2010 during a construction period**

The particular flatbed truck in Figure 46 gave a maximum acceleration of 0.025 g as shown in Figure 45. The weight and speed of the truck are not known. However, the traffic

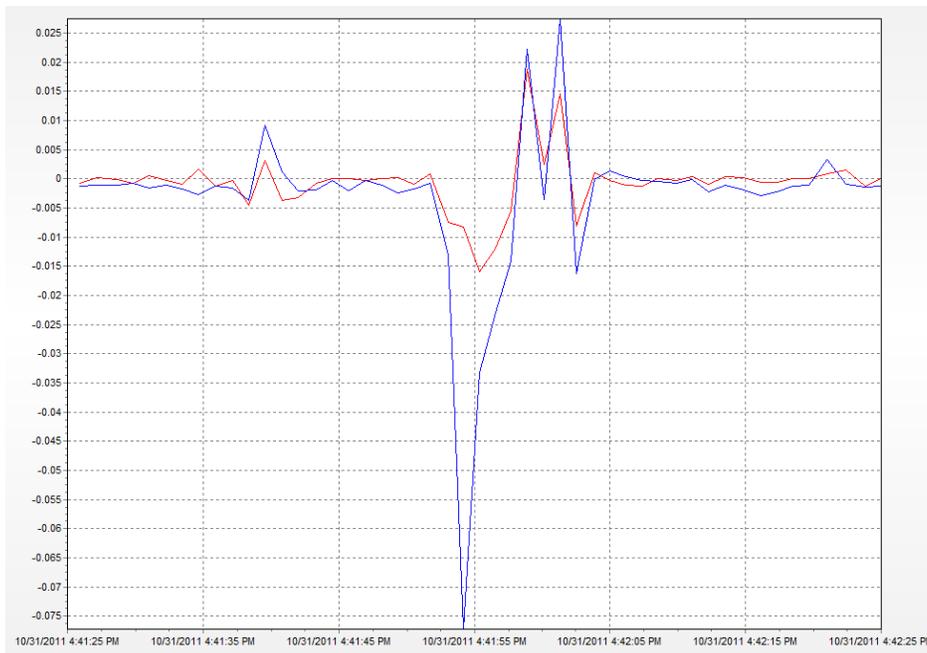
**Figure 47. Acceleration of 0.075 g at girder 2 on October 31, 2011**

In addition to special events and planned testing, real time accelerations are captured on screen. These responses are significantly larger than what was observed with controlled annual truck testing and are analyzed; these trucks represent what traffic actually is on the bridge daily. Over the course of three days, representative screen shots were captured; the highest daily response is shown in Figures 47-49.

As observed in Figures 47-49, ambient data show accelerations without knowledge of the truck weight or speed. On November 21, 2011 a fourth truck load test was carried out. UDOT Peerless Port of Entry 8037 No. Highway 6 weighed a continuous sample of 90 trucks. The port of entry is approximately 10 miles from the bridge. The research team collected the speed of each truck using a Pro Laser III LiDAR gun while the truck was over the bridge. Thus, both truck weight and speed are known. The sample set included trailers, tankers, flatbeds, cab, and small trucks. The times were taken as the trucks passed over the bridge, making it possible to match up the truck with the accelerometer data recorded. Pictures and signals are shown below in Figure 50.

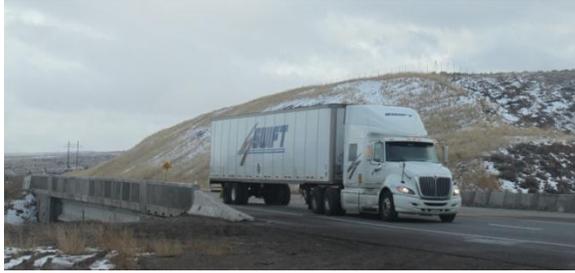
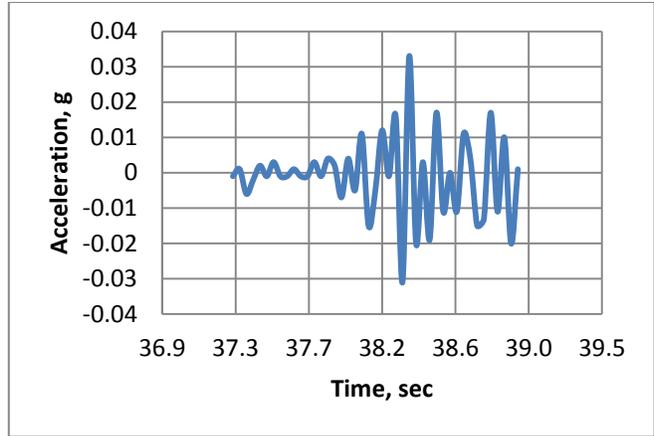
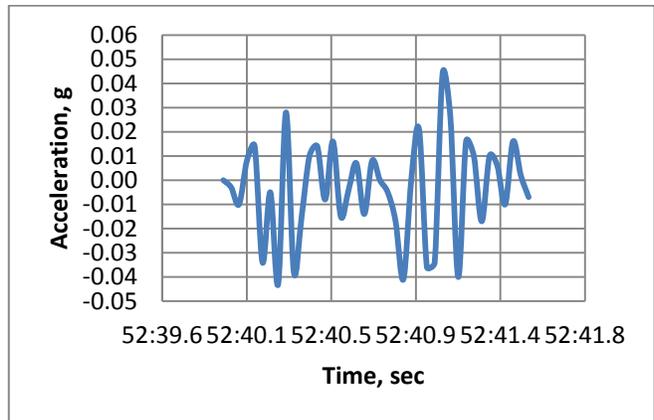
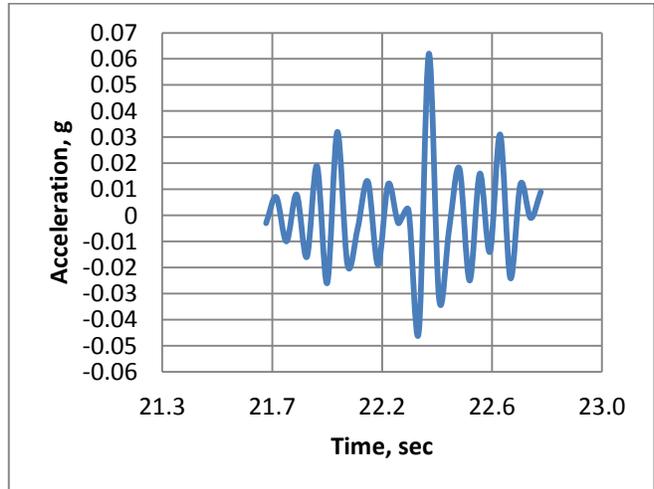
**Figure 50. Sample of trucks in the data set and their corresponding acceleration response**

**Truck weight = 60.98 kips,**

**Truck speed = 48 mph**

**Truck weight = 119.22 kips,**

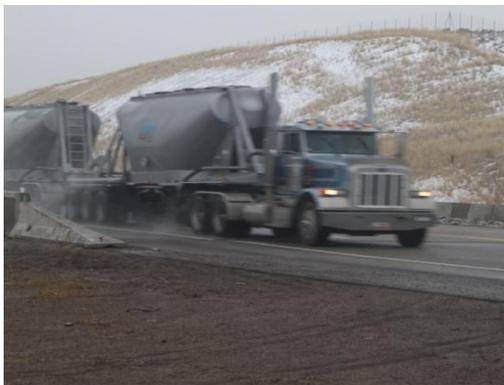
**Truck speed = 62 mph**

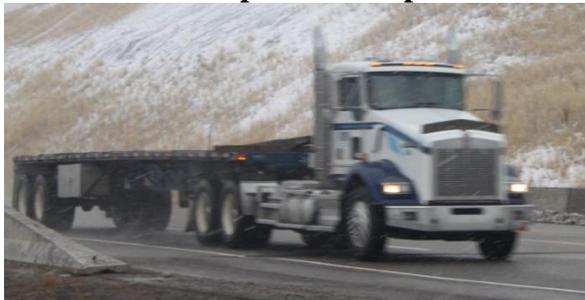
**Flatbeds are not weighed**

**Truck speed = 67 mph**

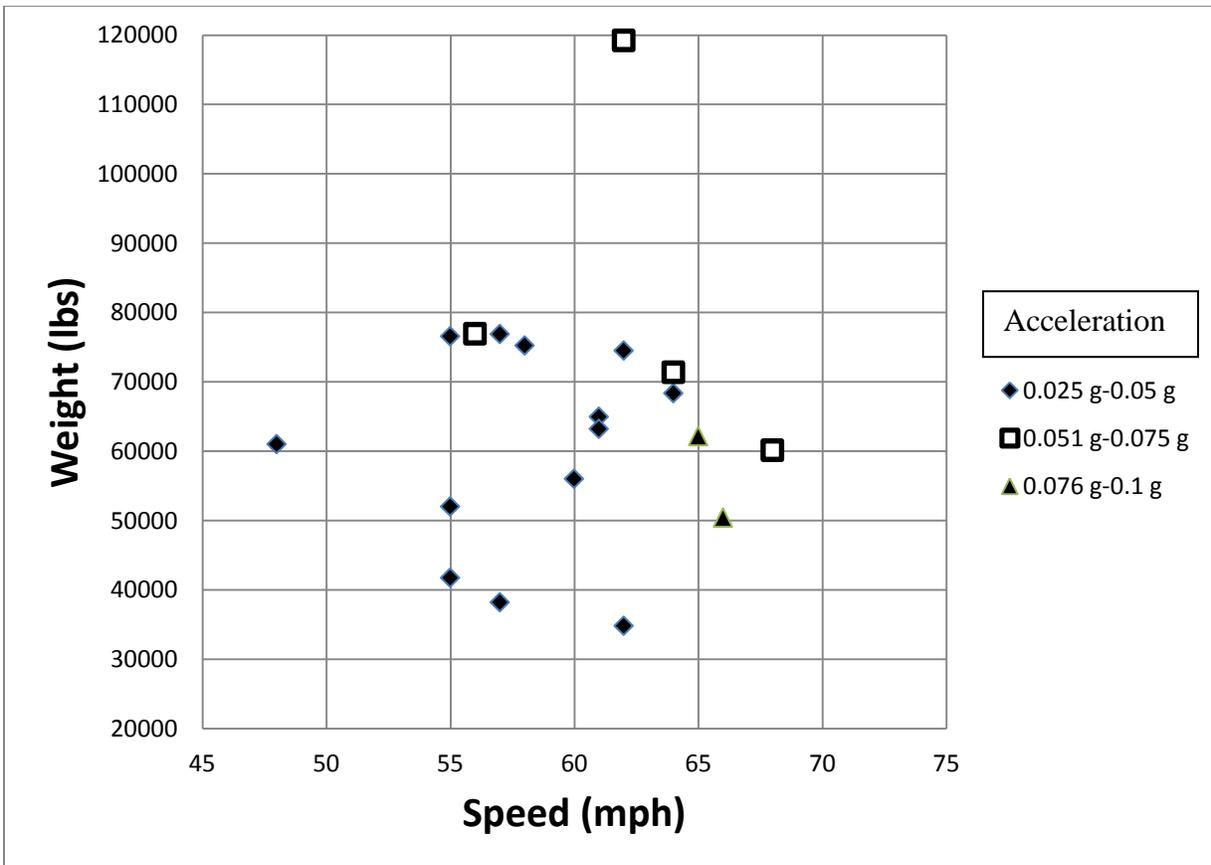
Figure 51. Acceleration as a function of weight and speed from Nov. 21, 2011 test

Of the data set, 19 trucks were able to be matched with a speed, weight, and acceleration signal and are shown in Figure 51 below. It should be noted that the acceleration response is grouped in the following ranges: 0 to 5%g, 5% to 7.5%g, and 7.5% to 10%g. The maximum acceleration was 0.105g from a flatbed truck that was hauling a load marked “oversized load” that weighed 62.14 kips and was traveling at a speed of 65 mph.

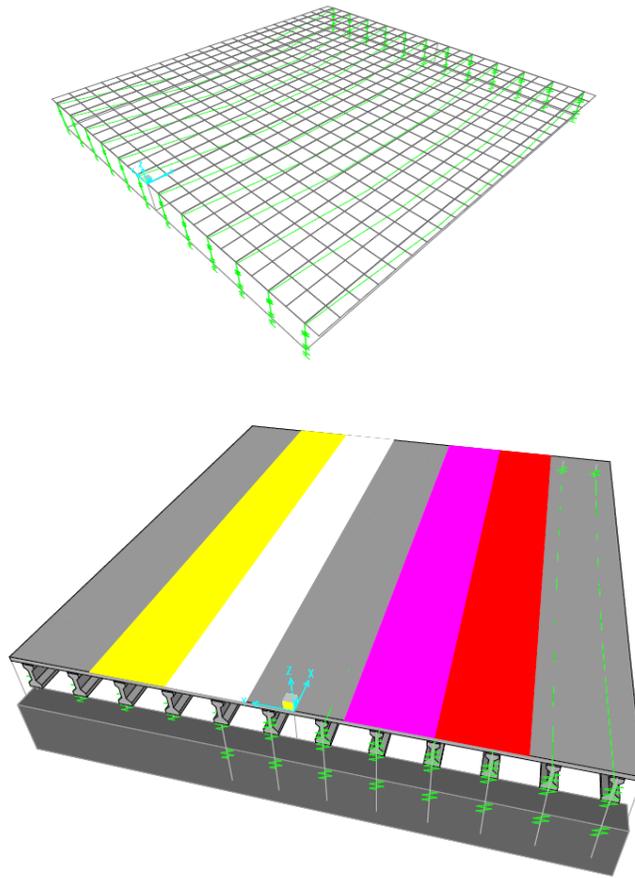
**Figure 55. Model showing lanes, girders and abutments**

SAP 2000 was used to generate finite element models of the bridge. The deck, girders, abutment springs and prestressed tendons were included in the model as shown in Figure 55. Area elements were used for the deck and girders, line elements for the prestressed tendons in the girders and spring elements for the abutments. The abutments were modeled as a fixed-fixed integral abutment condition with rotational springs.

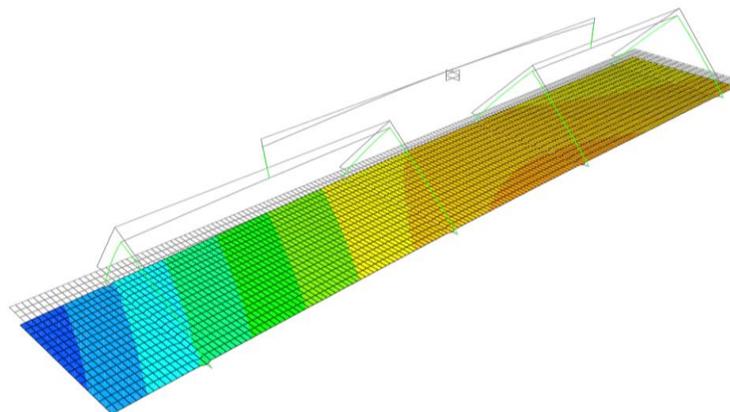
**Figure 72. Deflected panel with a maximum midline deflection of 0.34 inches**

The third lift was modeled with the parapet on the left side of the panel. The parapet was modeled as an equivalent distributed load placed at the end of the panel. The maximum deflection in the air was 0.34 inches as shown in Figures 72 and 73. The maximum stress on the top of the slab while in the air was 276 psi with a corresponding midline strain of  $59 \mu\epsilon$  shown in Figures 74 and 75. These values correspond well with recorded top strain and are close to the experimentally observed strains in the panel. The calculated deflections are small but reasonably close compared to the predicted deflections (Nix 2010).
